**ASSET INVENTORY, RAPID APPRAISAL REPORT AND
REHABILITATION PLAN OF BLOCK 2 AND 8 OF
NARAYANI IRRIGATION SYSTEM**

Final Report

**Submitted By:
Everest Engineering Consultant
Dillibazar, Kathmandu
Nepal**

December, 2006

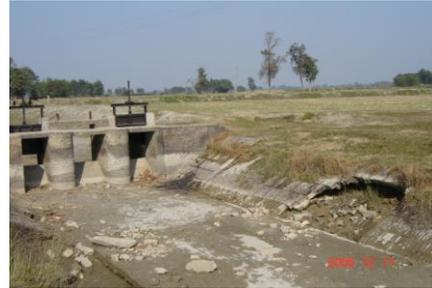
View of cross regulator in MSC 2

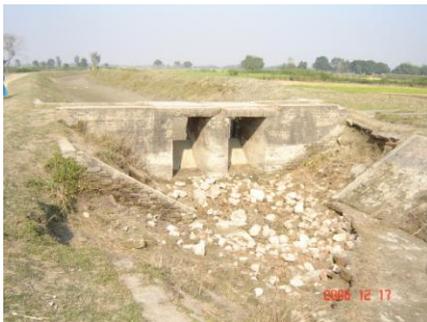
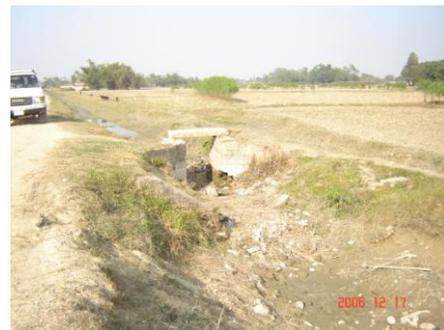
The length of main secondary canal of block 2 is 10.65. Almost all part of the canal length is unlined, except u/s and d/s of structures where the canal is lined. The shape of the canal in u/s is so far not disturbed, however the d/s shape is totally deteriorated. The right bank in tail end is almost disappeared and has come to the level of field. Reshaping is needed in head reach and middle reach structures where the offtake structures lies. The outlet has to be regulated with gates. Most gates are damaged or stolen and the offtake remain without gates hampering water distribution equitably. Only the frame of the outlet exists and the gate needs to be installed. In total NRs 45.16 million is needed for light maintenance and reshaping of the canal system in block 2.

The scouring in MSC of block 2

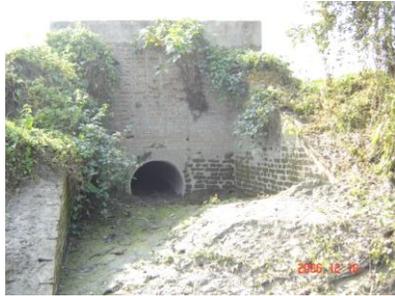
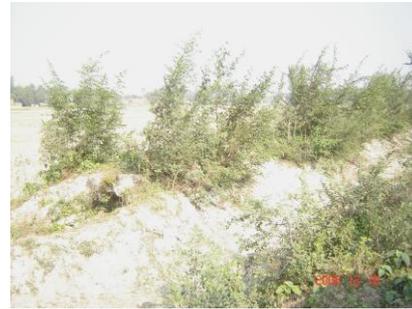
The length of the MSC of block 8 is 4.7 Km. The total length of the canal is earthen and needs to be reshaped in various chainages. Gates are missing in all

outlet structures. The structures in canal need to be protected with normal maintenance. Regulating gates are corroded and needs to be replaced with the new one. The tentative cost estimated for this purpose NRs 33.75 million

Silt deposition and bush growing in block 8 canals.
